## **SITE INSPECTION FOR THE 28<sup>TH</sup> STREET LANDFILL, SUTTERS LANDING PARK, AND THE DELLAR TRUST PROPERTY, SACRAMENTO COUNTY**

**INSPECTION REPORT**

**FACILITY:** 28<sup>th</sup> Street Landfill/Sutters Landing/Dellar Trust Property

**INSPECTION DATE:** 13 January 2009

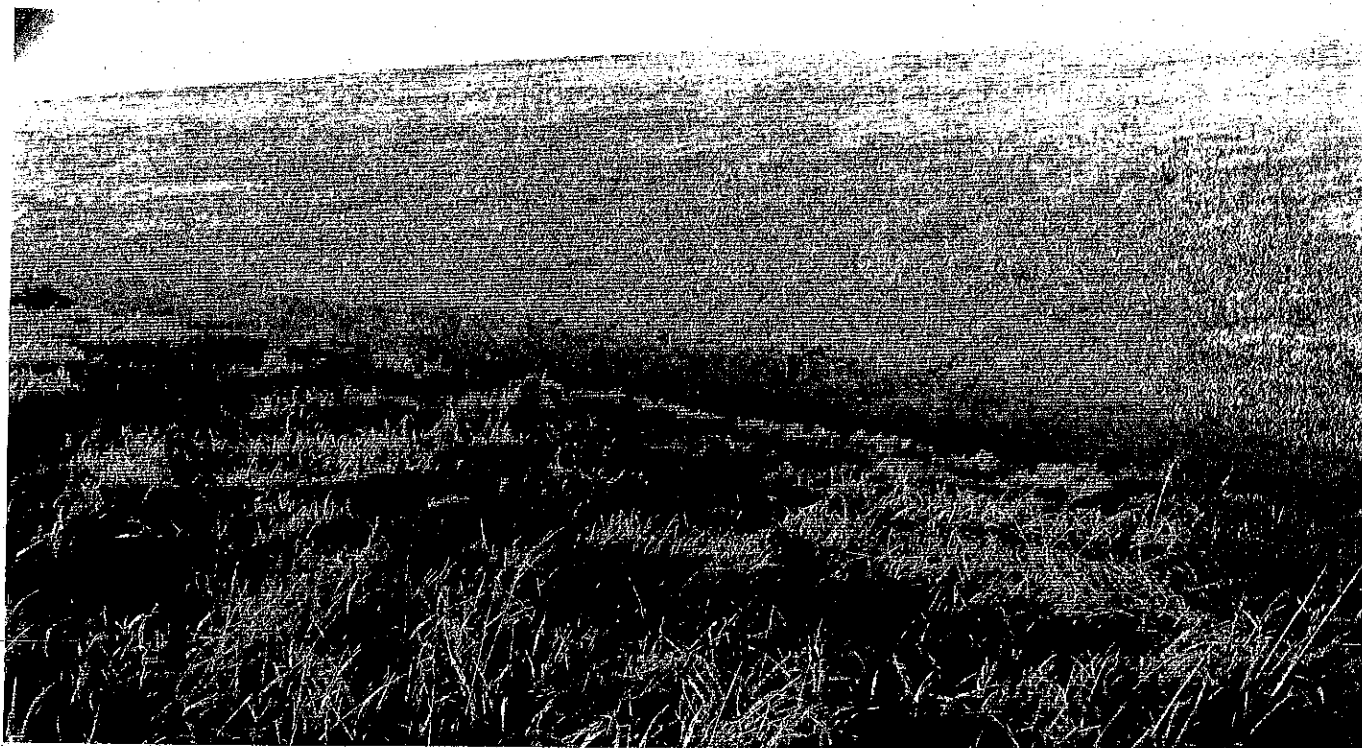
Figure 2: Top deck and eastern drainage ditch that has standing water. Note thick stand of vegetation on top deck. Drainage ditch needs to be graded to drain.

Staff inspected the 28th Street Landfill in conjunction with the Sutters Landing project and Dellar Trust Property. No significant concerns were noted on the closed units of the landfill. Staff observed animal burrows along the southeast side slope of unit A but according to City staff, the side slope was constructed of concrete and soil that allows the burrowing animals den space below the surface. There was no observed refuse or seeps along this side slope nor burrows observed on the top deck. The vegetation cover along the side slope and top deck is well established and in excellent shape. One minor issue observed was standing water in a drainage ditch. Staff recommended regarding the ditch. See Figures 1 and 2.

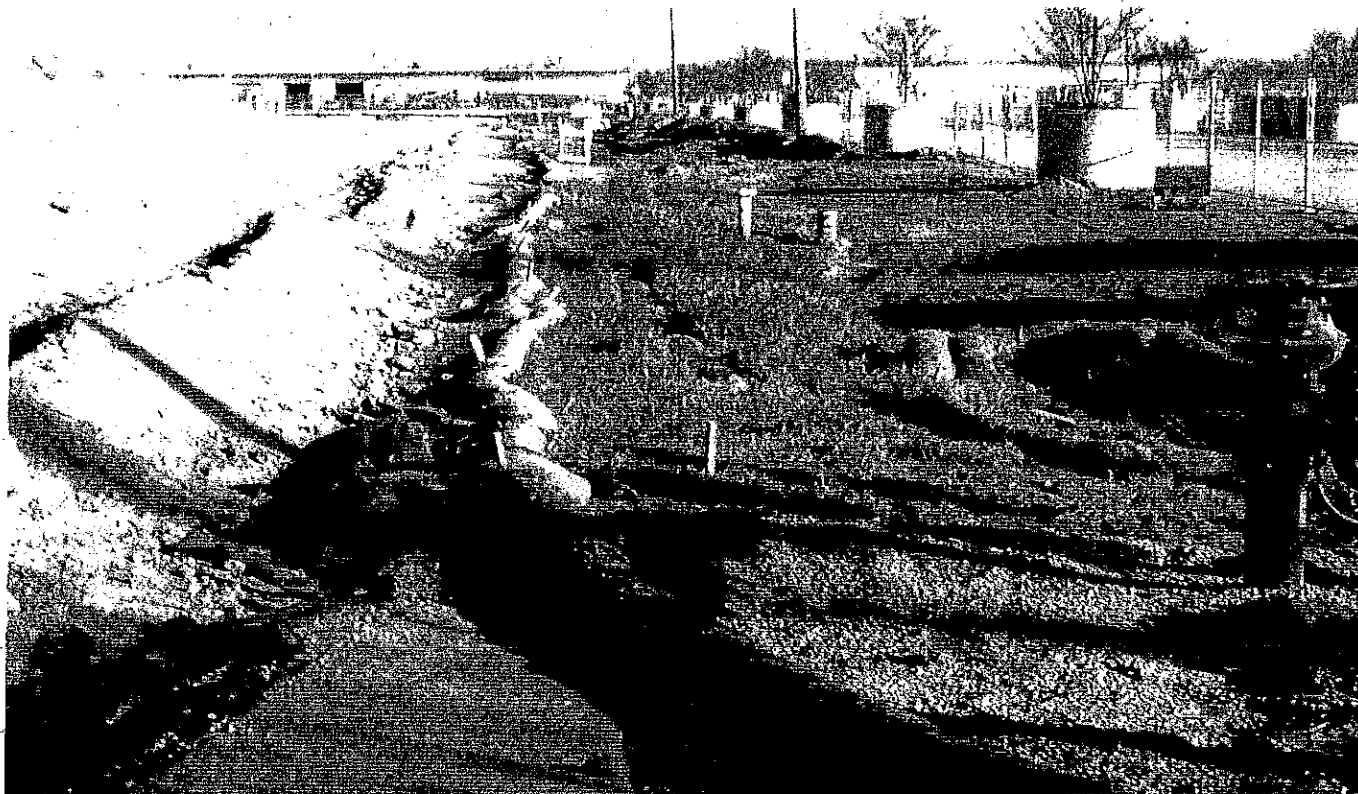
Staff inspected the Sutters Landing Park. The City has placed fill mounds around the doggy park area and is currently finishing up work on the geomembrane barrier layer and drainage system. The subdrains for the park are functional, which should allow the City to continue working through the winter and finish by early spring. The City will begin Phase 2 improvement which include landscaping, ball courts, restroom and other park amenities north and NE of the dog park. Phase 2 should be completed by end of summer. No significant storm water concerns, but may be worth another storm water inspection in a month or so to check site status and storm water compliance. As shown in Figures 3 and 4, the site is nearing final grade and storm water controls are in place.

Figure 4: Storm water controls in place.

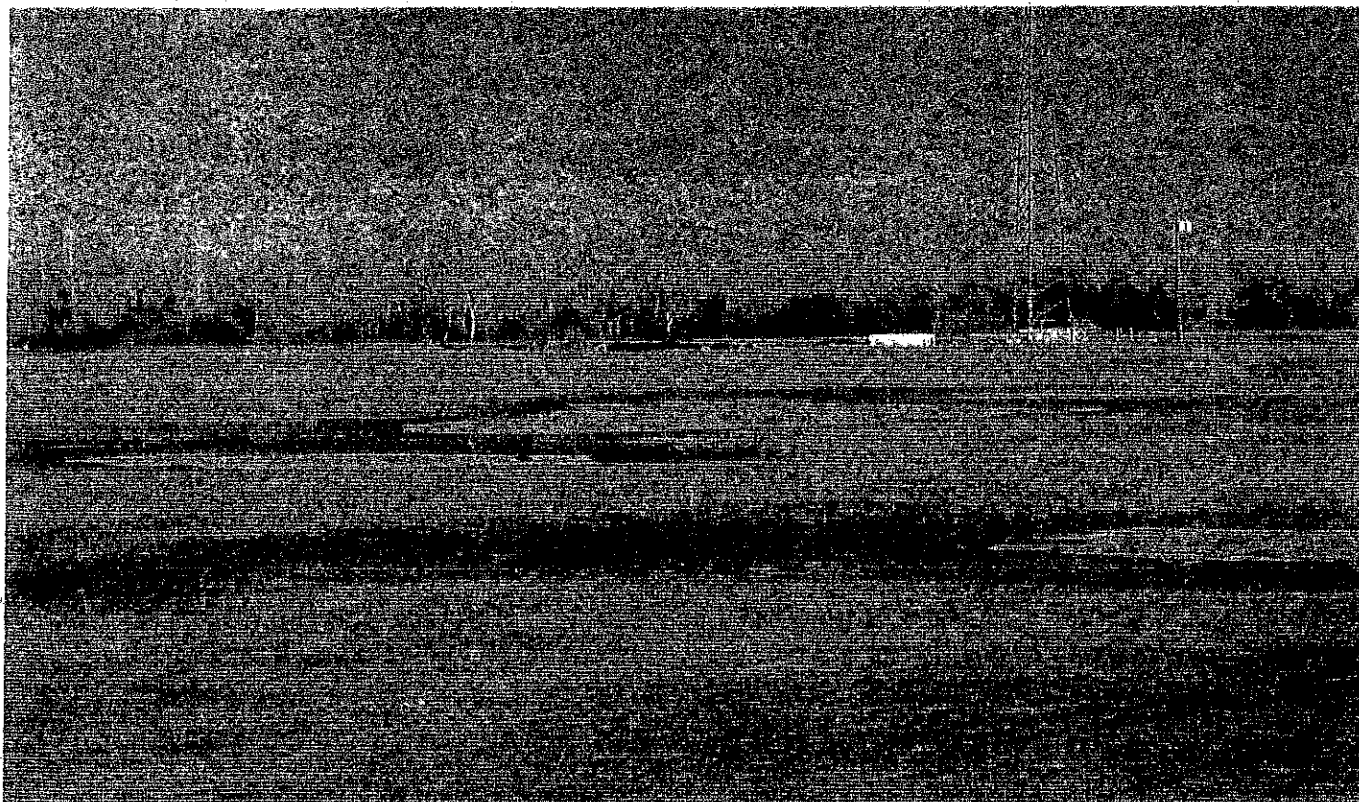
The construction storm water permit requires that storm water controls be installed prior to the wet season. However, the current surface of the property is hummocky and by all appearances, self contained. Since differential settlement has occurred over many years and the existing soil cover is likely highly permeable, it is staff's opinion that accumulating storm water is unlikely to leave the site. Standing water on the landfill surface was not evident. The 65,000 cubic yards of soil stockpiled was placed in a flat lift approximately 10 feet high.

The top deck is compacted from heavy equipment and only had minor standing water during the site inspection. Staff's initial concern about the installation of storm water controls were alleviated during this site inspection. Based on the observations made it appears the site can and has absorbed what little precipitation has fallen. There doesn't appear to be a natural storm water drainage off site and the landfill surface resides at an elevation below the surrounding properties. As shown in Figure 6 there exists a significant grass buffer on both sides of the soil lift. In accordance with the CAO, the Discharger has to October 2010 to complete the proposed final cover.

Figure 5: Looking north across the deck of 65,000 cubic yards of stockpiled soil.
